Visual identification groove removed

Read the repair kit number marked on the main tube marking

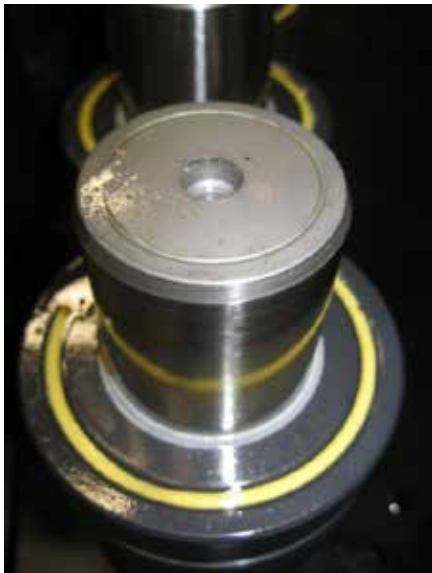
K	A	L	L	E	R		X	X	X	X	X	X	X	X	-	X	X	X	X	X							
	P	C	H	A	R	G	E		M	A	X		1	5	0	B	A	R		A	T	2	0	°	C			
	M	A	D	E		I	N		S	W	E	D	E	N			F	L	U	I	D	/	N	2		G	R	2
	R	E	P	K	I	T		X	X	X	X	X	X	X	X	X	X	X	X	X	X	X	X	X	X	X	X	X
	S	E	A	L		K	I	T		C	H	A	N	G	E	S	:			/				/

Example of a present combination of identification grooves on a TU 5000 spring.

To secure that the correct repair kit is being used, always read the repair kit number marked on the main tube marking. We do not recommend repairing gas springs older than 2002.
